Date: 30 August 2023
Project No: LTC21220-A
Revision: B

**RE: SHALLOW SOIL TEST REPORT
FUTURE RESIDENTIAL FOUNDATIONS
LOT 12, 115 EUREKA STREET, ARANUI**

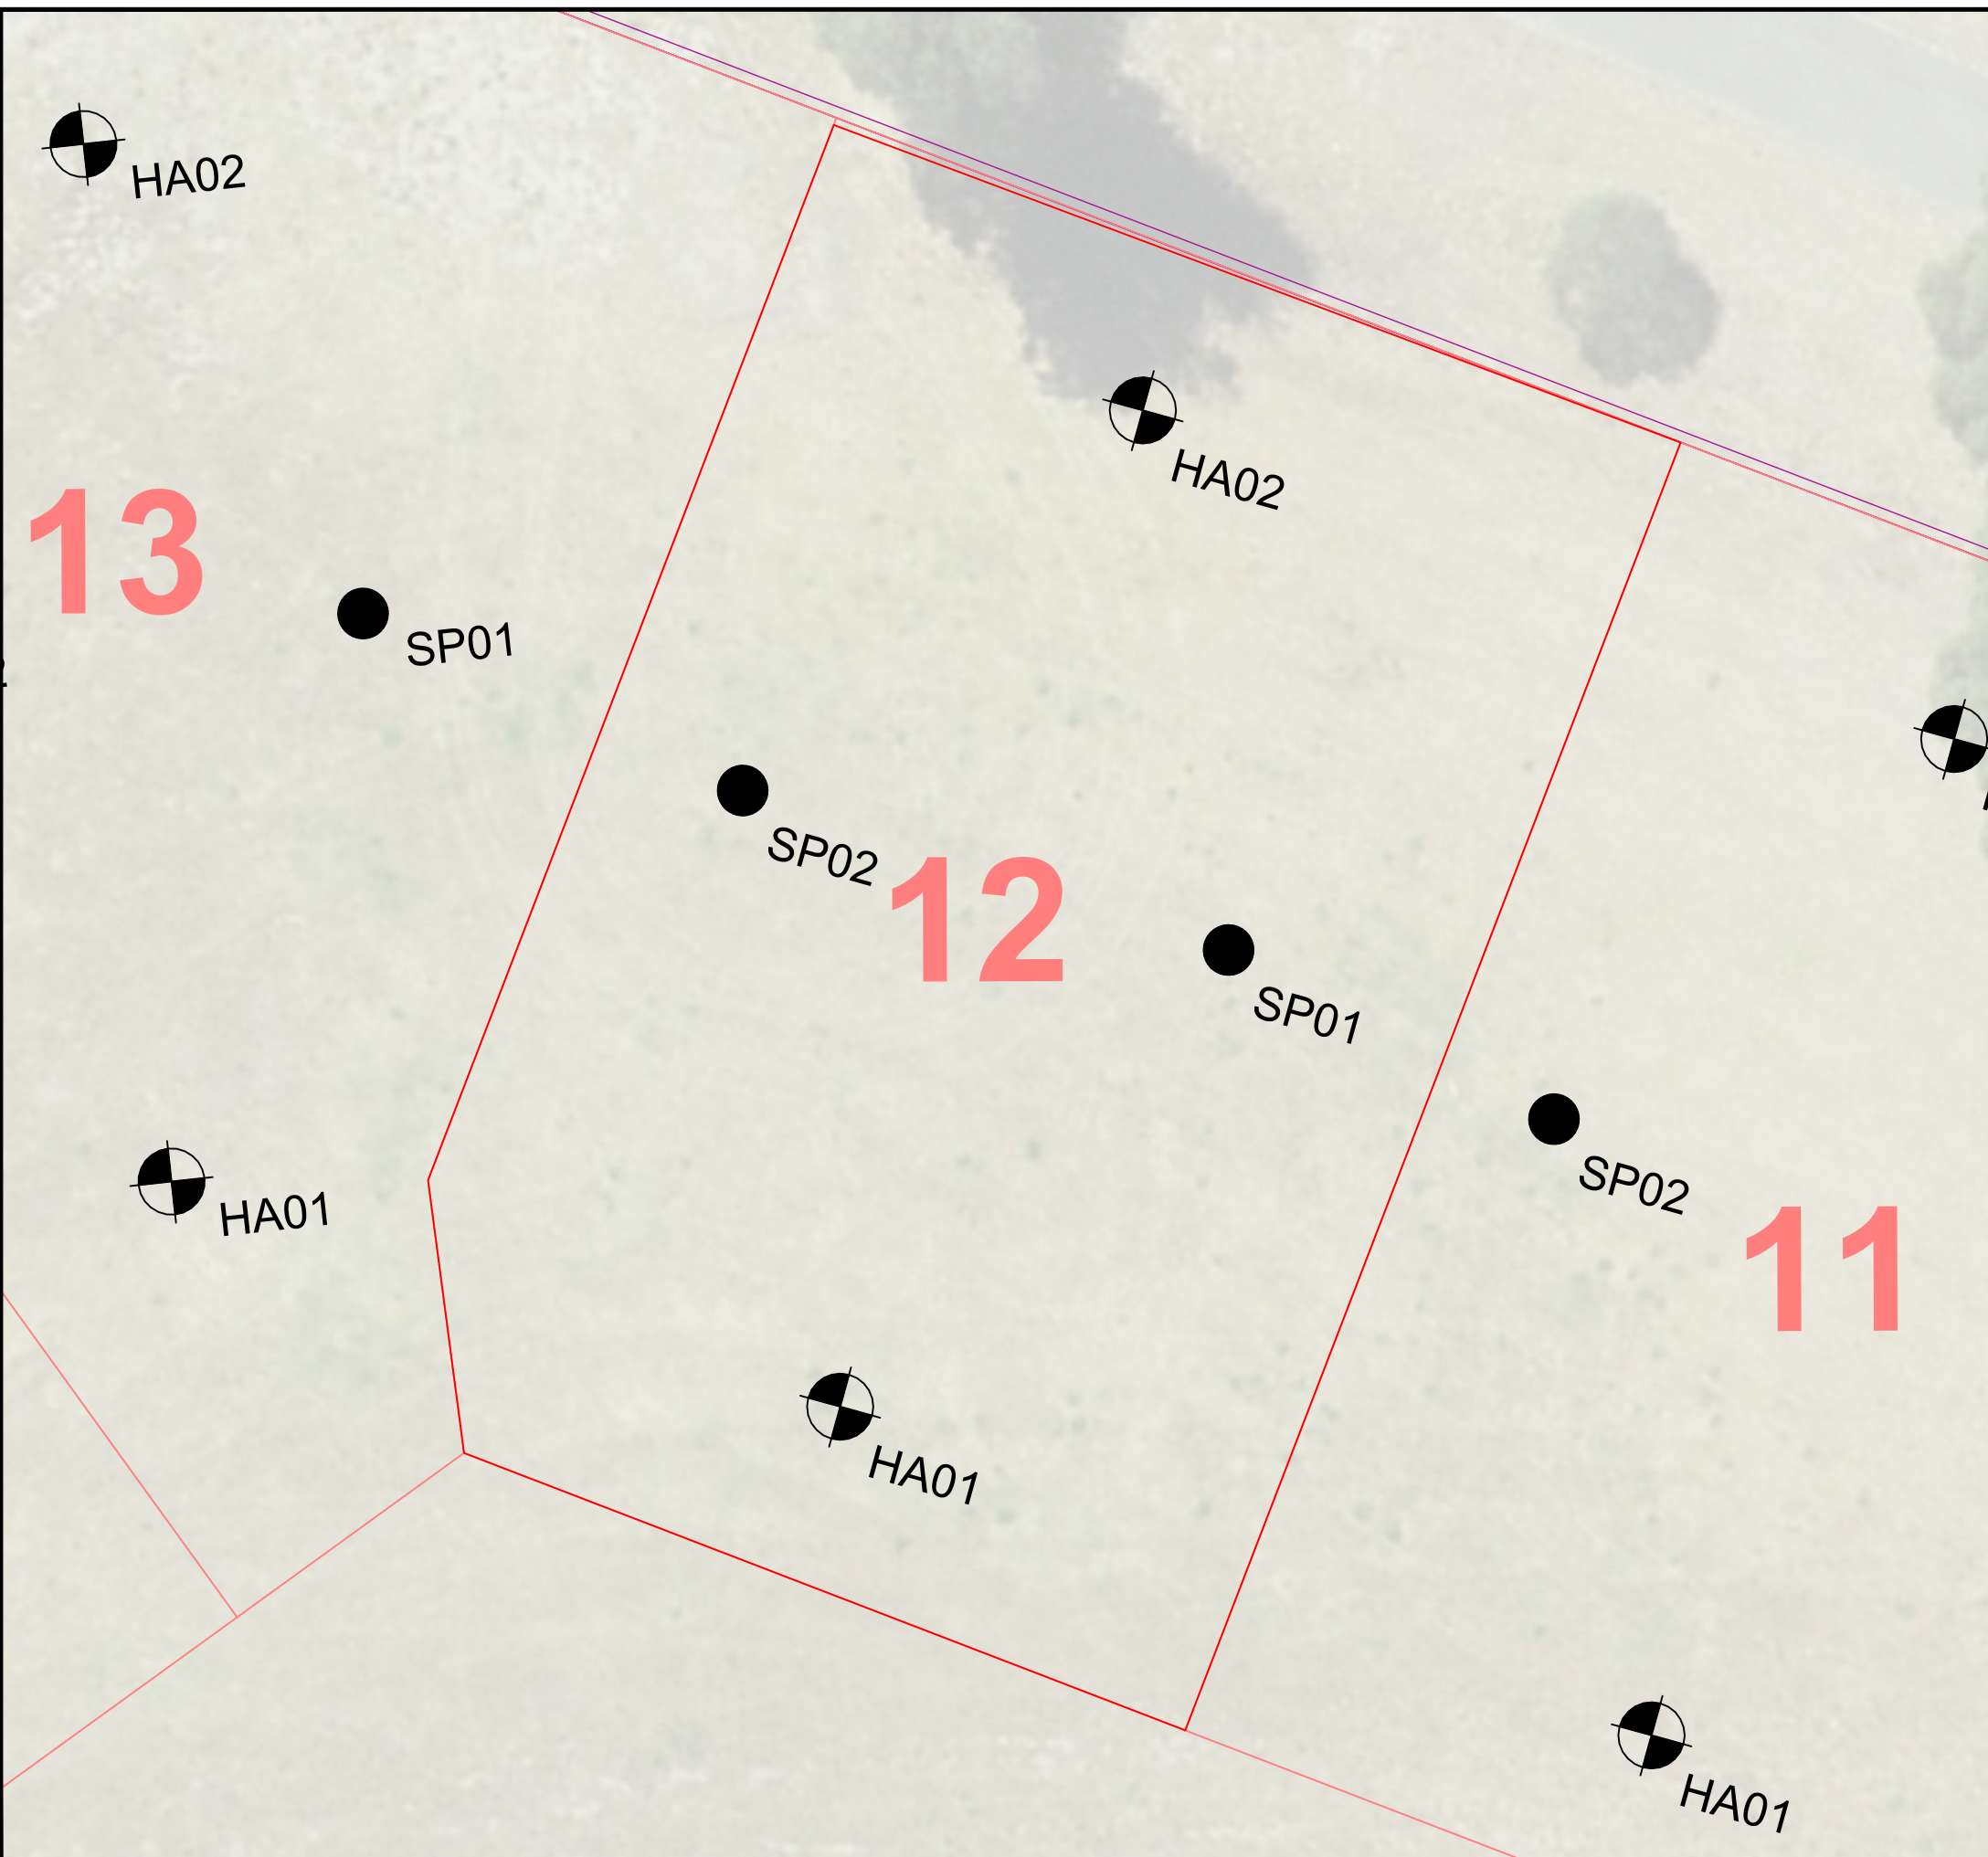
Test Location Plan
 Lot 12, 115 Eureka Street,
 ARANUI, CHRISTCHURCH

LandTech investigated the site on 24 May 2023, conducting two hand augers with corresponding Scala Penetrometer tests (SPs) and two additional SPs. The locations of the hand auger and SPs were measured using inferred lot boundaries and are approximate only. The test locations are shown on our LandTech *Test Location Plan*, Drawing No. Lot 12/ TLP, attached to this report.

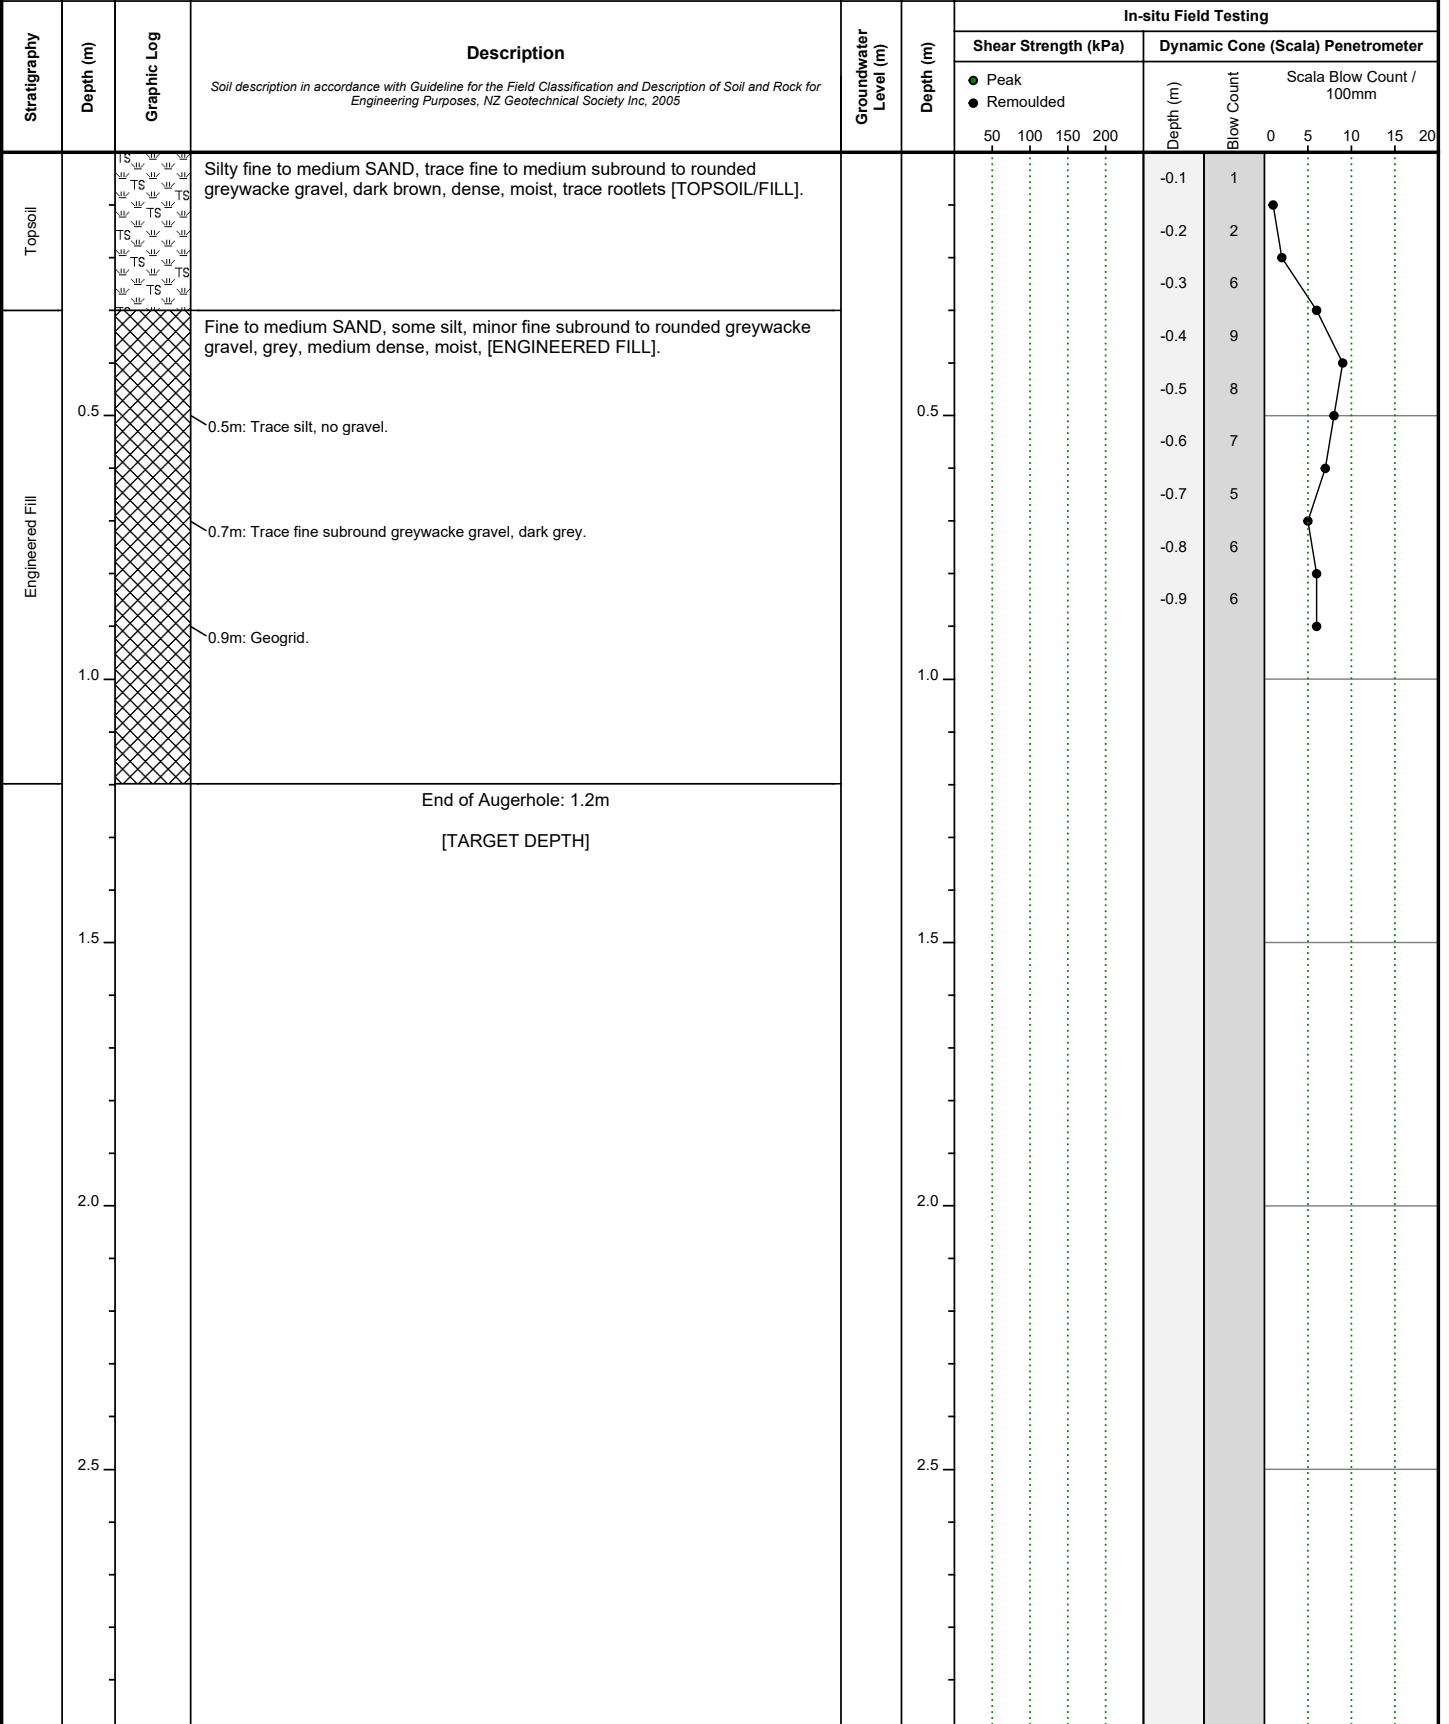
Augerhole No.: Lot 12 - HA02

Topsoil was encountered within the hand augers from the ground surface to 0.3m depth, which was typically a dark brown silty sand material with a trace of gravel. Engineered fill was encountered below the topsoil to the base of auger holes, which was a compacted light grey sand material with a trace of silt and gravel. The hand augers were terminated at 1.2m depth below ground level to avoid damage to the geotextile layer which was installed at 1.5m depth below ground level. Groundwater was not encountered during testing.

Target depth achieved.

All foundations must be embedded to a minimum depth of 0.3m below ground level, where an Ultimate Bearing Capacity of 200kPa and a strength reduction factor of (ϕ_s) 0.5 is available. Foundations excavations should expose engineered fill of appropriate bearing capacity. All topsoil and unsuitable materials should be removed below foundations and floor slab areas, and where required layers of compacted hardfill should be placed to the underside of foundations.

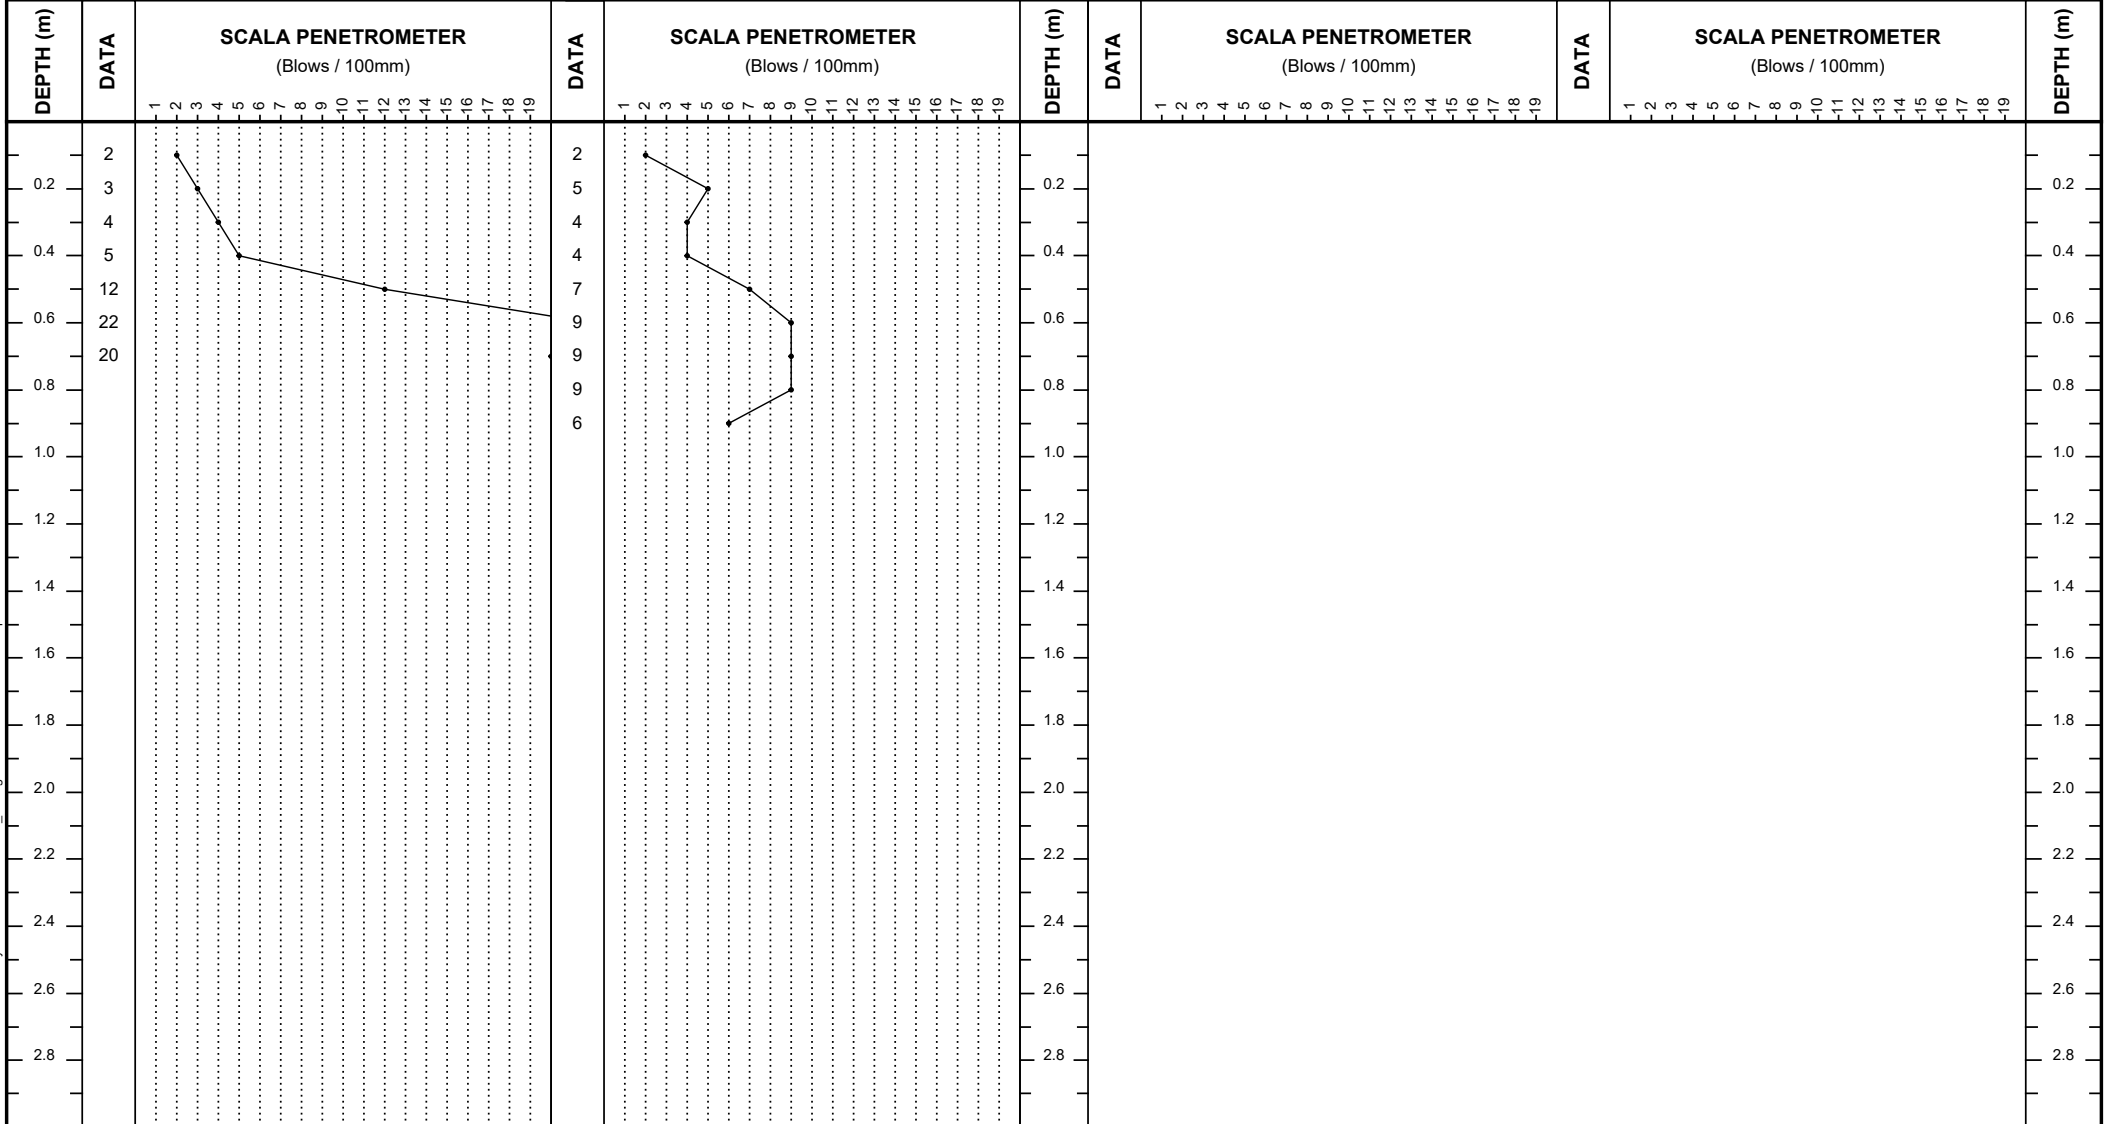
SPs at each of the four locations returned results between 3 and 22 blows per 100mm penetration below the topsoil and within the engineered fill layer. SPs were terminated at 0.9m depth to confirm near surface bearing capacities, and to avoid damage to the geogrids and geotextile. In addition, the density of the engineered fill and bearing capacity of its underlying subgrade have been confirmed via extensive geotechnical inspection and fill compaction testing during subdivision earthworks.
