Date: 30 August 2023
Project No: LTC21220-A
Revision: B

**RE: SHALLOW SOIL TEST REPORT
FUTURE RESIDENTIAL FOUNDATIONS
LOT 6, 115 EUREKA STREET, ARANUI**

Test Location Plan

Lot 6, 115 Eureka Street,
ARANUI, CHRISTCHURCH

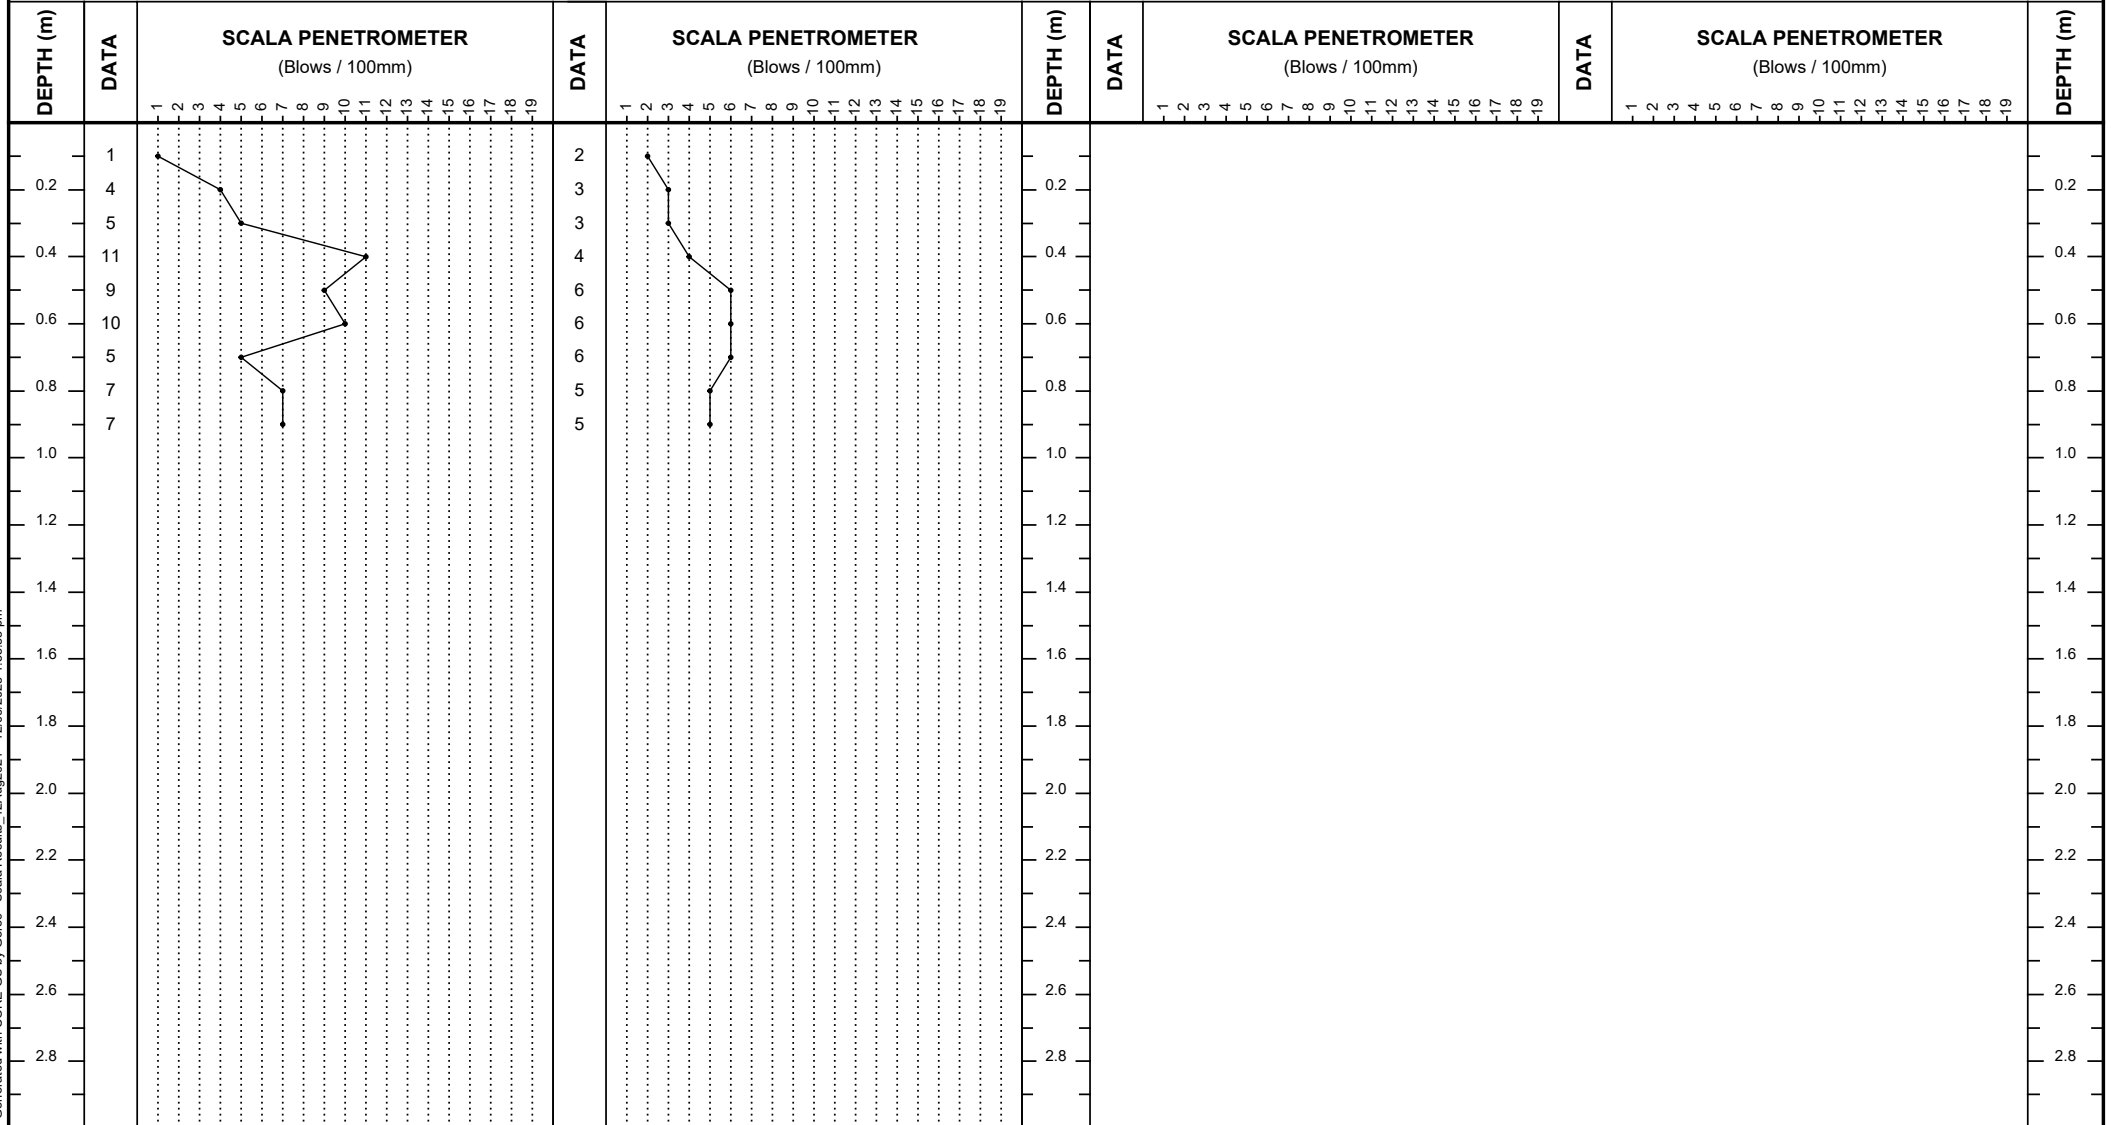
LOT 6- SP01

SPs at each of the four locations returned results between 3 and 11 blows per 100mm penetration below the topsoil and within the engineered fill layer. SPs were terminated at 0.9m depth to confirm near surface bearing capacities, and to avoid damage to the geogrids and geotextile. In addition, the density of the engineered fill and bearing capacity of its underlying subgrade have been confirmed via extensive geotechnical inspection and fill compaction testing during subdivision earthworks.

Tested By: KP
Ground Conditions: Near level, Topsoil.
Coordinates: NZTM2000 E 1576435.93
 N 5183012.39
Test Date: 08-Jun-23

Tested By: KP
Ground Conditions: Near level, Topsoil.
Coordinates: NZTM2000 E 1576439.49
 N 5183020.83
Test Date: 08-Jun-23
